Gloucestershire Warwickshire Steam Railway Plc
Risk Assessment for Repair of Class 37 traction motor banding with an adhesive - Diesel Loco

Risk Assessment - Repair of Class 37 traction motor banding with an adhesive

Reference No: DIE-44050-40
 Version No: 3
 Assessment Approver: Kevin 'Kev' Jarvis

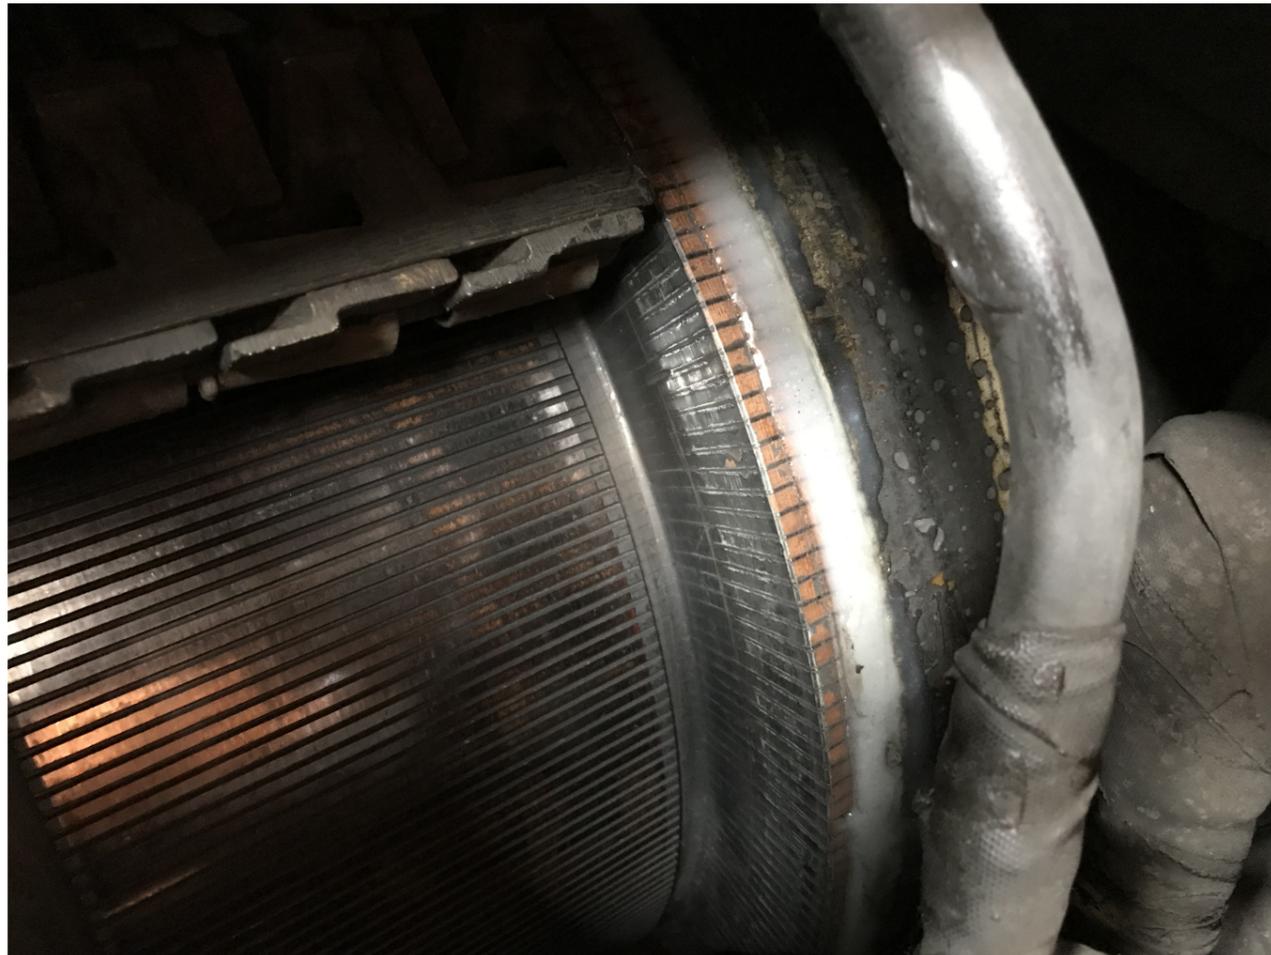
Reference: UI-44050-843

Repaired traction motor - Repaired traction motor picture

Adhesive repair to traction motor
